Investigation of Steel-Stringer Bridges: Superstructures and Substructures, Volume II

Final Report
October 2007

Sponsored by
the Iowa Highway Research Board (Project TR-522)
and the Iowa Department of Transportation (CTRE Project 04-184).

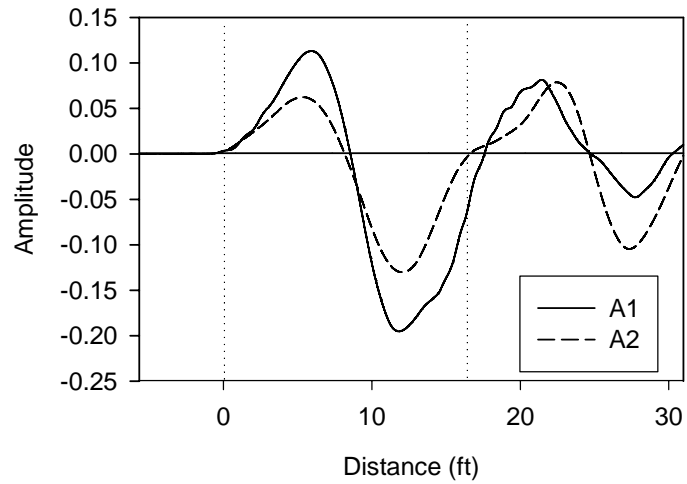
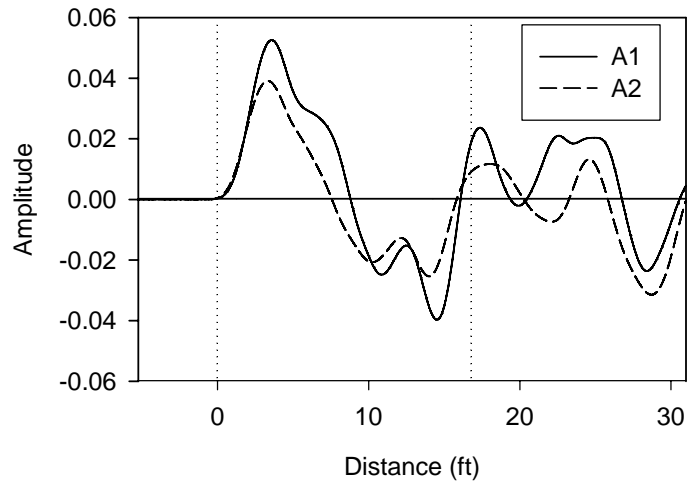
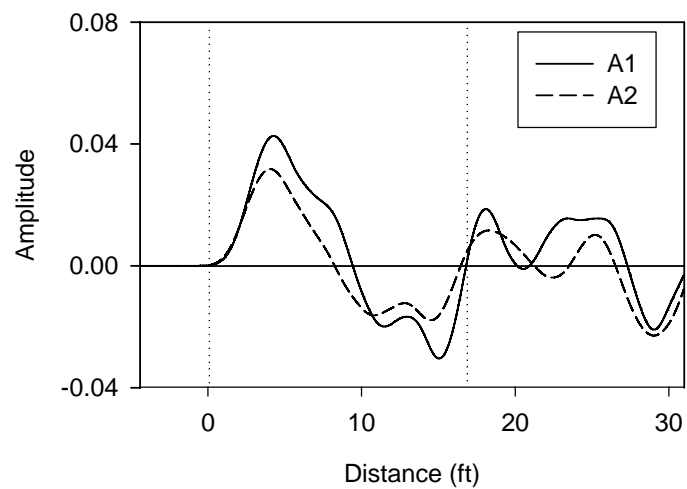
Figure C1. Pile integrity test results at pile no. 2 at the north abutment (distance between A1 and A2 = 5 ft)

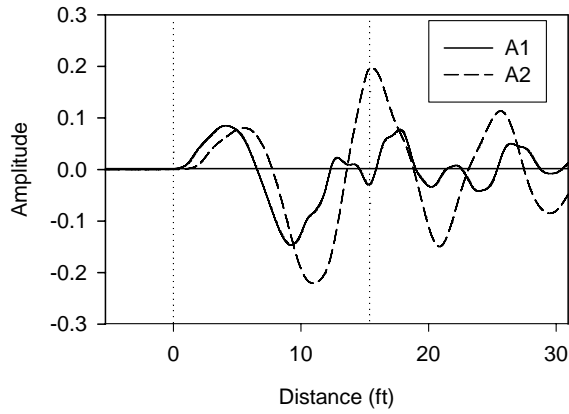
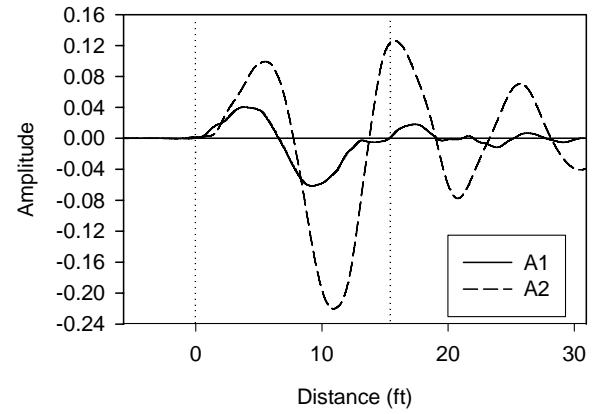
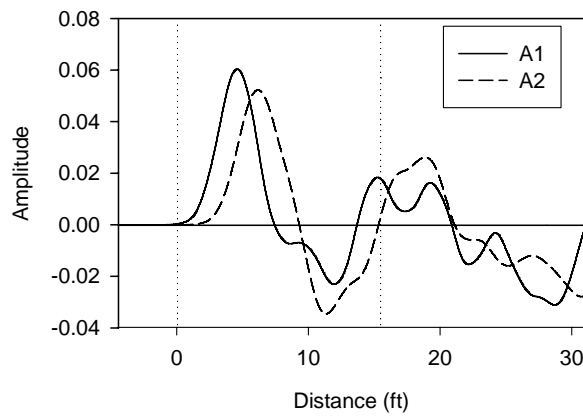
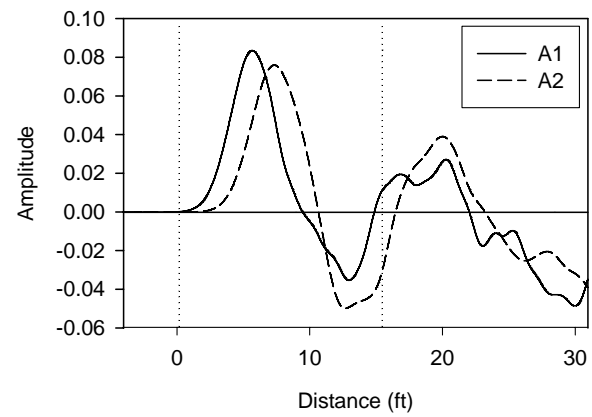
Figure C2. Pile integrity test results at pile no. 3 at the north abutment (distance between A1 and A2 = 3 ft)

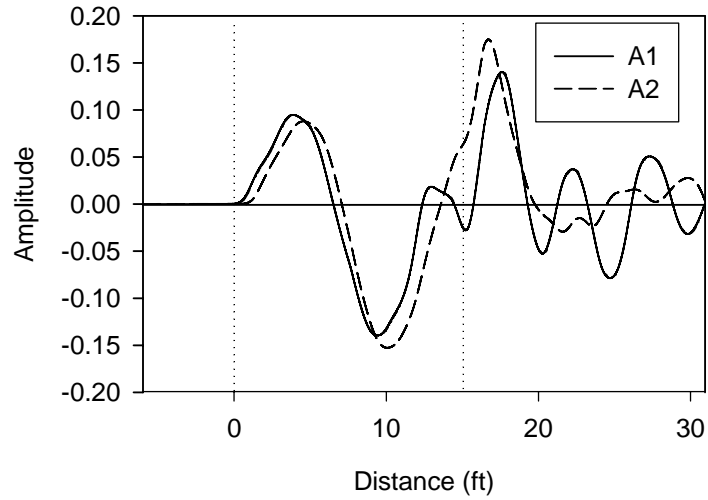
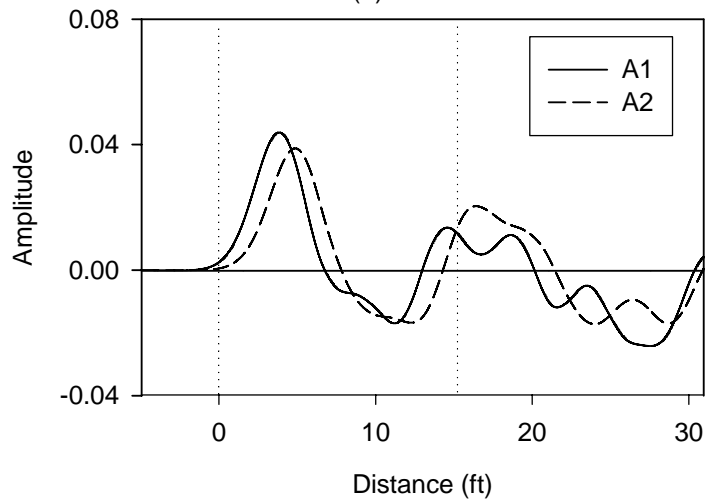
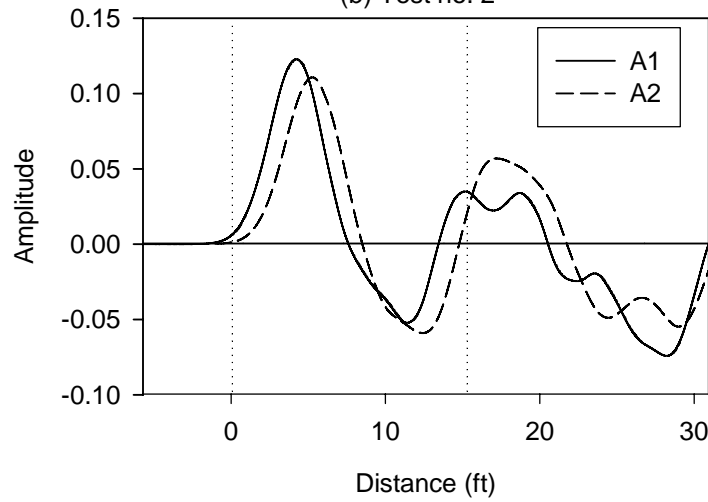
Figure C3. Pile integrity test results at pile no. 3 at the north abutment (distance between A1 and A2 = 2 ft)

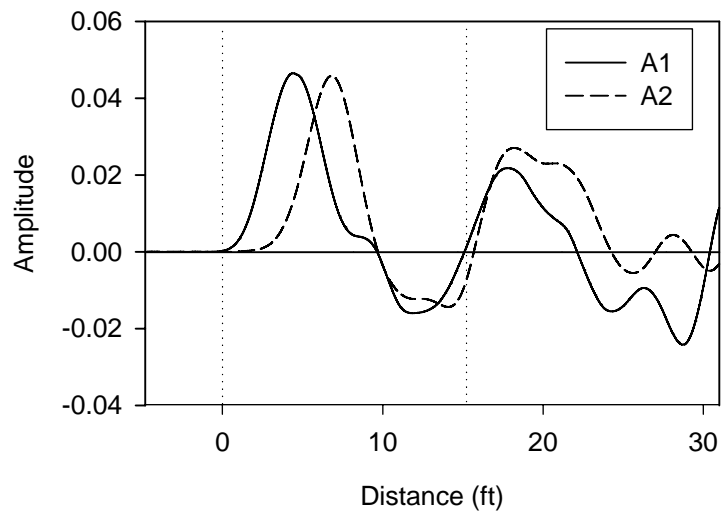
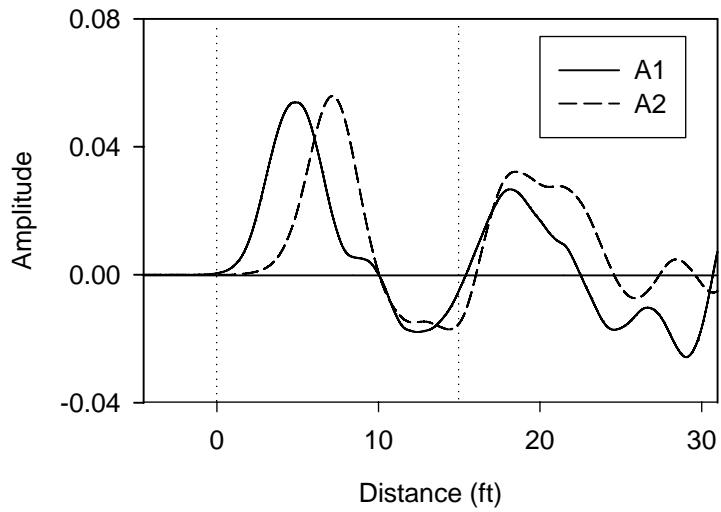
Figure C4. Pile integrity test results at pile no. 3 at the north abutment (distance between A1 and A2 = 5 ft)

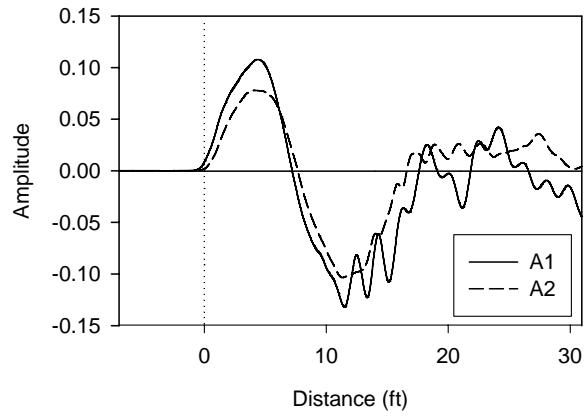
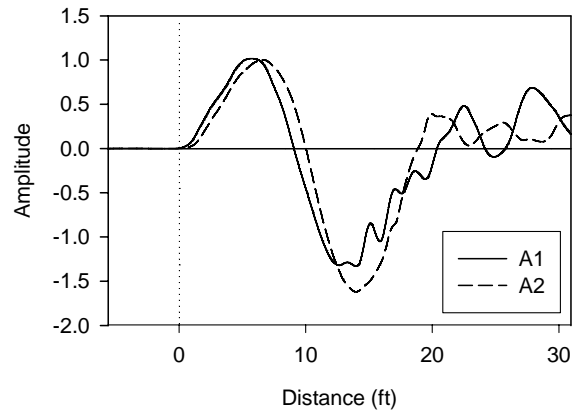
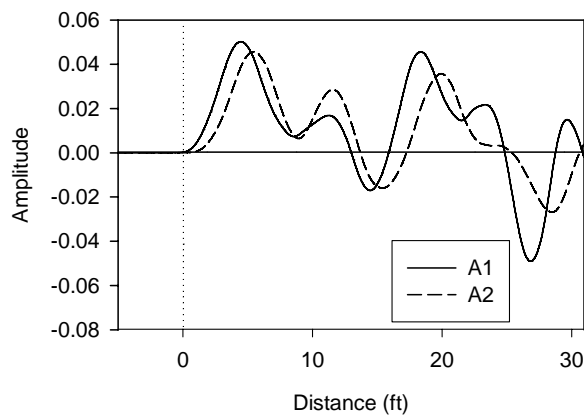
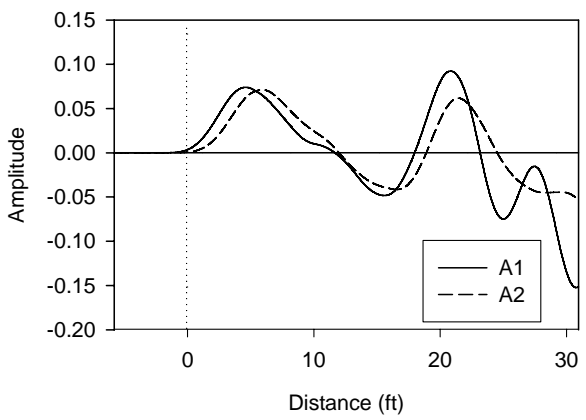
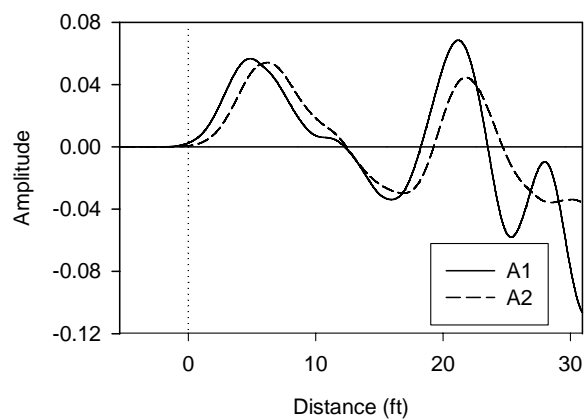
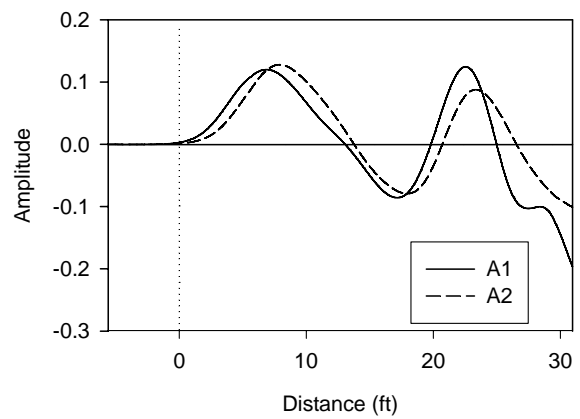
Figure C5. Pile integrity test results at pile no. 5 at the south abutment (distance between A1 and A2 = 2 ft)

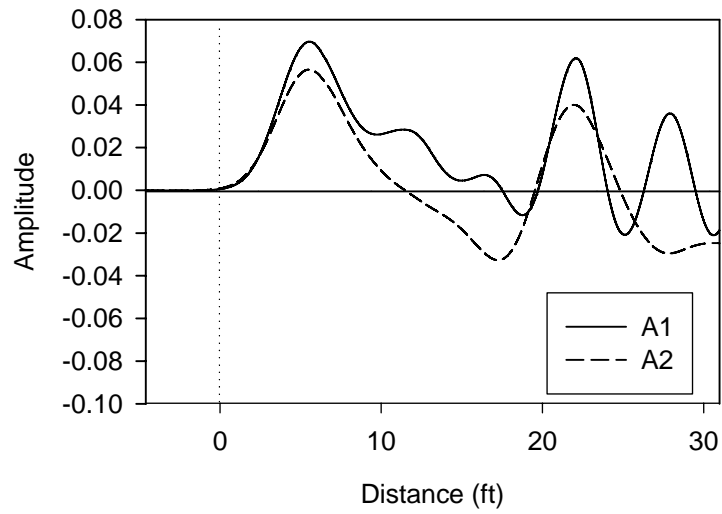
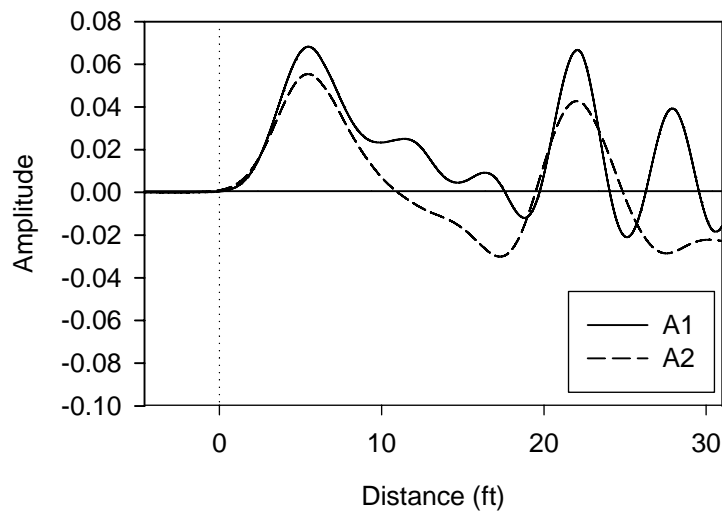
Figure C6. Pile integrity test results at pile no. 5 at the south abutment (distance between A1 and A2 = 5 ft)

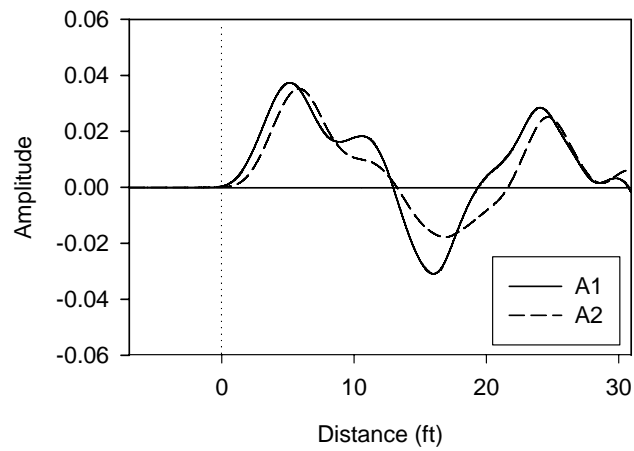
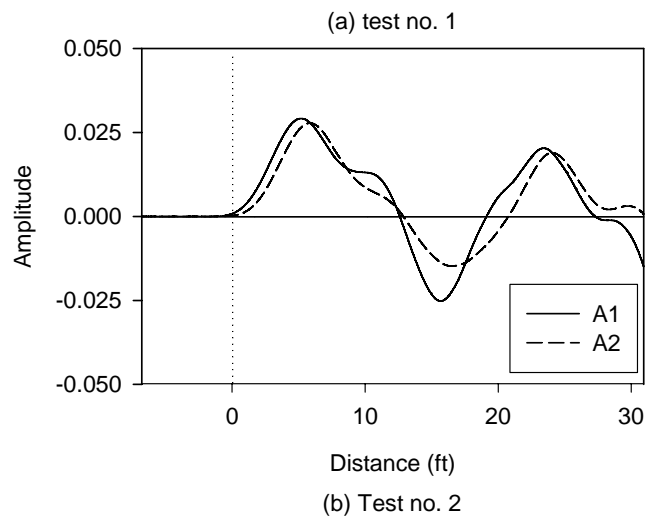
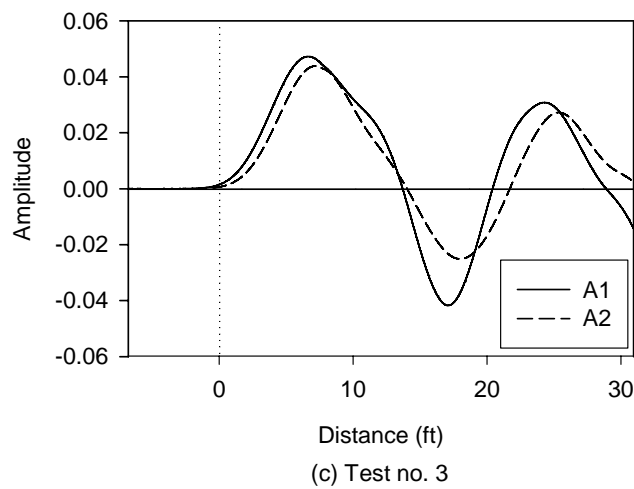
Figure C7. Pile integrity test results at pile no. 3 at the south abutment (distance between A1 and A2 = 2 ft)

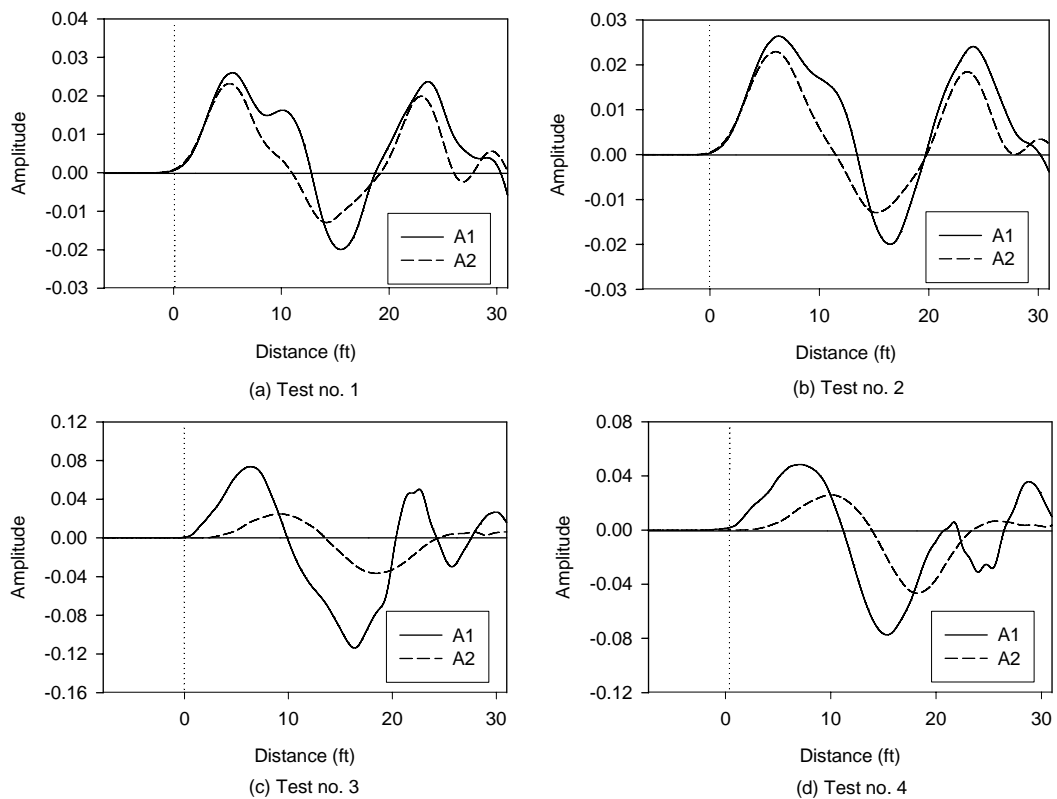
Figure C8. Pile integrity test results at pile no. 3 at the south abutment (distance between A1 and A2 = 4.5 ft)

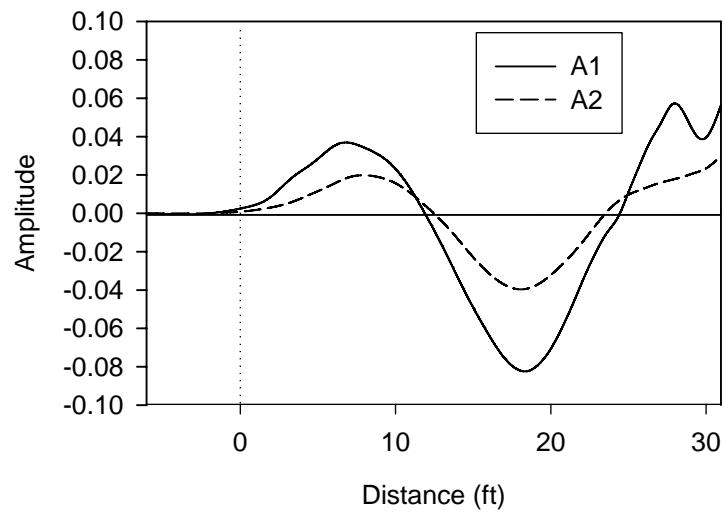
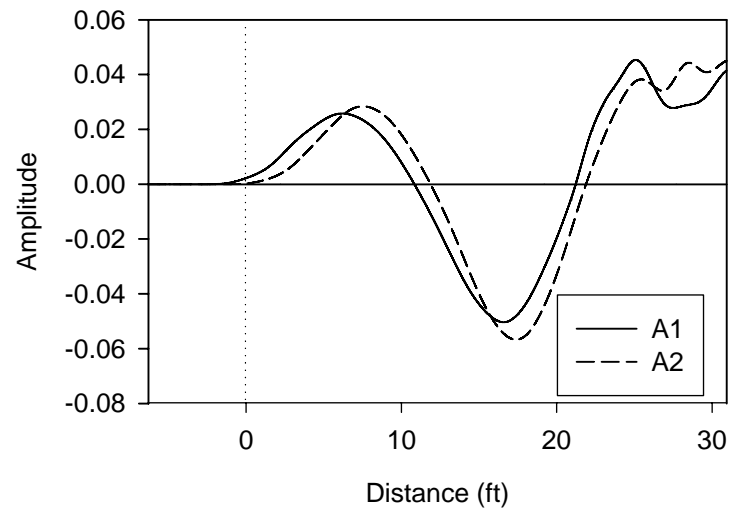
Figure C9. Pile integrity test results at pile no. 3 at the south abutment (distance between A1 and A2 = 2.5 ft)

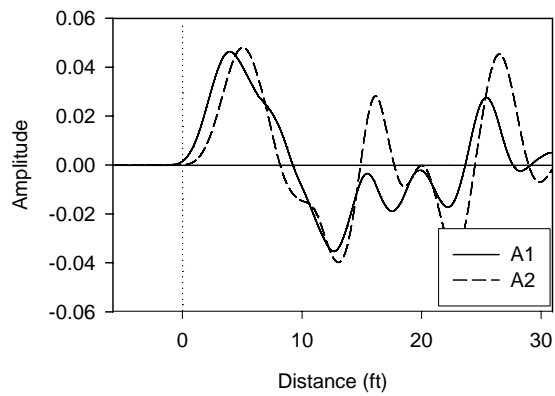
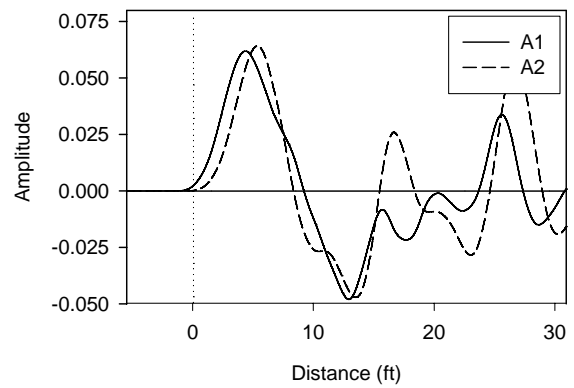
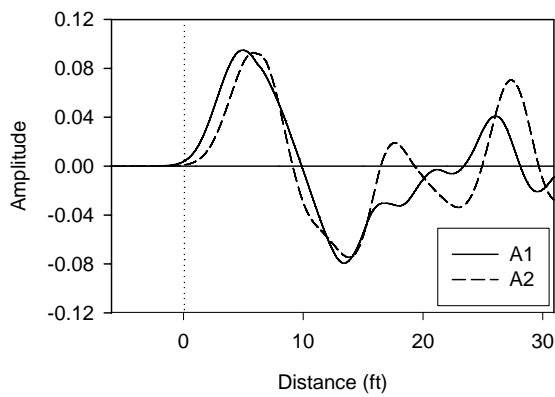
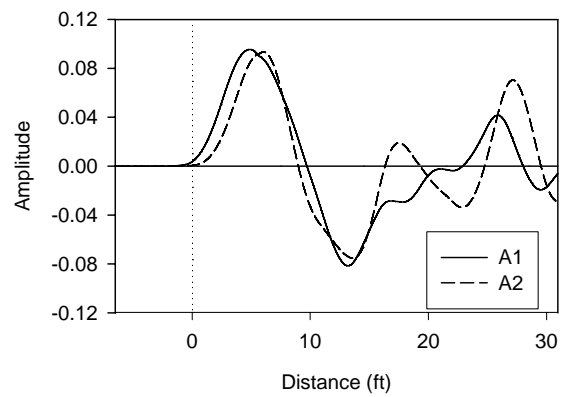
Figure C10. Pile integrity test results at pile no. 2 at the south abutment (distance between A1 and A2 = 2 ft)
